**CHARACTERIZATION OF AN OXIDE
DISPERSION STRENGTHENED SUPERALLOY,
MA 6000E, FOR TURBINE BLADE APPLICATIONS**

Y.G.KIM and H.F.MERRICK

**INCO RESEARCH AND DEVELOPMENT CENTER
SUFFERN, NEW YORK 10901**

FINAL REPORT

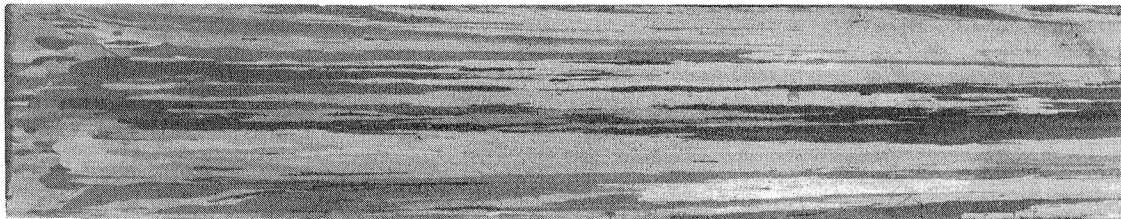
(a) Extruded Bar

(b) Extruded plus hot rolled plate

FIGURE 2: Macrostructure of extruded, and extruded plus hot rolled MA 6000E after zone annealing at 1260°C with a 6.8 cm/hr furnace travel rate.

The extruded and extruded plus hot rolled materials were subjected to a zone annealing heat treatment (Ref. 11) to produce a highly elongated grain structure. The zone annealing furnace was set with a maximum hot zone temperature of 1260°C. A furnace travel rate of 6 cm/hr was employed. Typical macrostructures of zone annealed material are shown in Figure 2. Highly elongated grains were developed in the direction of extrusion and hot working. Elongated grain structures give superior high temperature strengths in ODS alloys (Refs. 2 and 11).

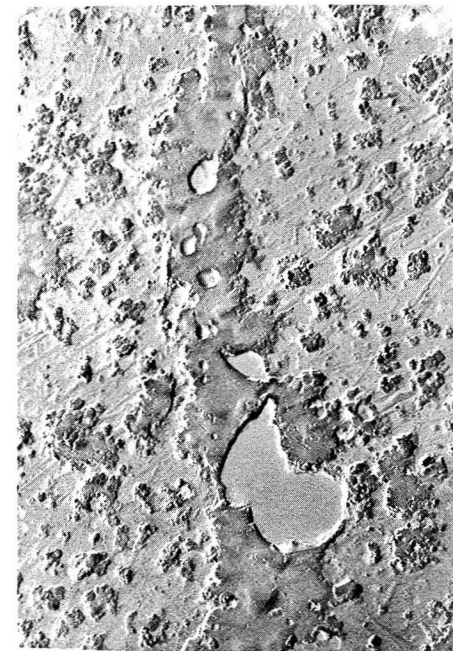
No Exposure

760°C/538 MPa (78 ksi) for
165 hrs

1093°C/152 MPa (22 ksi) for
53 hrs

FIGURE 13: Effect of creep exposure on γ' morphology in MA 6000E.

Creep Deformation Mechanisms: The mechanism of creep deformation at 760°C and 1093°C was studied using replicas and thin foils of crept samples. Figure 13 shows the γ' morphology as a function of creep test temperature and stress. Figure 13a shows the as-heat treated condition (without creep exposure). The γ' precipitates are uniformly dispersed, with an average size of about 0.2 μm in diameter. The yttrium oxide particles can also be seen within the γ' precipitates, as well as in the matrix. The microstructure of a sample tested at 760°C and 538 MPa for 165 hours is shown in Figure 13b. Little change in γ' morphology or size was observed for this exposure. However, a significant change in γ' size and morphology occurred in a short time in material tested at 1093°C. Figure 13c shows γ' in a specimen, exposed for 53 hours at 1093°C with a stress of 152 MPa.

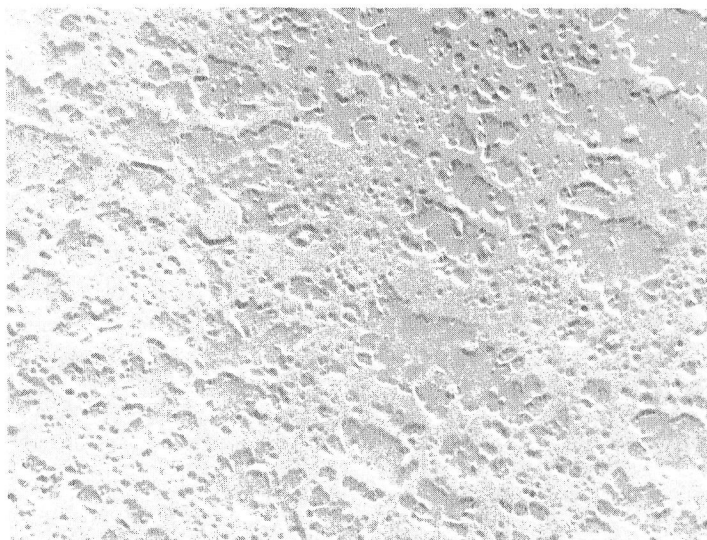
(a) As heat treated and rupture tested
at 760°C/538.2 MPa

(b) Specimen D91-4-2 exposed 1000 hrs at
815°C/262.2 MPa, then rupture tested
at 760°C/538.2 MPa

FIGURE 20: Effect of isothermal prior creep exposure
on the γ' morphology in MA 6000E.

(c) Specimen D91-3-2 exposed 1000 hrs at 954°C/207 MPa, then rupture tested at 760°C/538.2 MPa

(d) Specimen D91-5-2 exposed 1000 hrs at 1093°C/103.5 MPa, then rupture tested at 760°C/538.2 MPa

creep exposure is associated with the pronounced changes in morphology of the γ' precipitates. These changes are illustrated in Figure 20. Prior creep exposure at 815°C, Figure 20b, results in a fairly uniform coarsening of γ' . The γ' precipitates become more rounded and there is some evidence of agglomeration. Prior creep exposure at 954°C leads to pronounced alignment of the γ' normal to the stress axis. Such a phenomenon has been observed in many nickel-base superalloys containing relatively large volume fractions of γ' . The present observations in MA 6000E appear to be in accordance with theoretical predictions (Ref. 13 and 14). On the other hand, prior creep exposure at 1093°C results only in pronounced coarsening of γ' with only little indication of alignment. It would thus appear that alignment is impeded if the γ' growth rate is high and if the γ' volume fraction (coarse particle spacing) is small. The γ' solvus in MA 6000E is approximately 1163°C.
